**Loss of Pitch Control on Takeoff  
Emery Worldwide Airlines, Flight 17  
McDonnell Douglas DC-8-71F, N8079U  
Rancho Cordova, California  
February 16, 2000**

**NTSB/AAR-03/02**

**NTSB/AAR-03/02  
PB2003-910402  
Notation 7299A  
Adopted August 5, 2003**

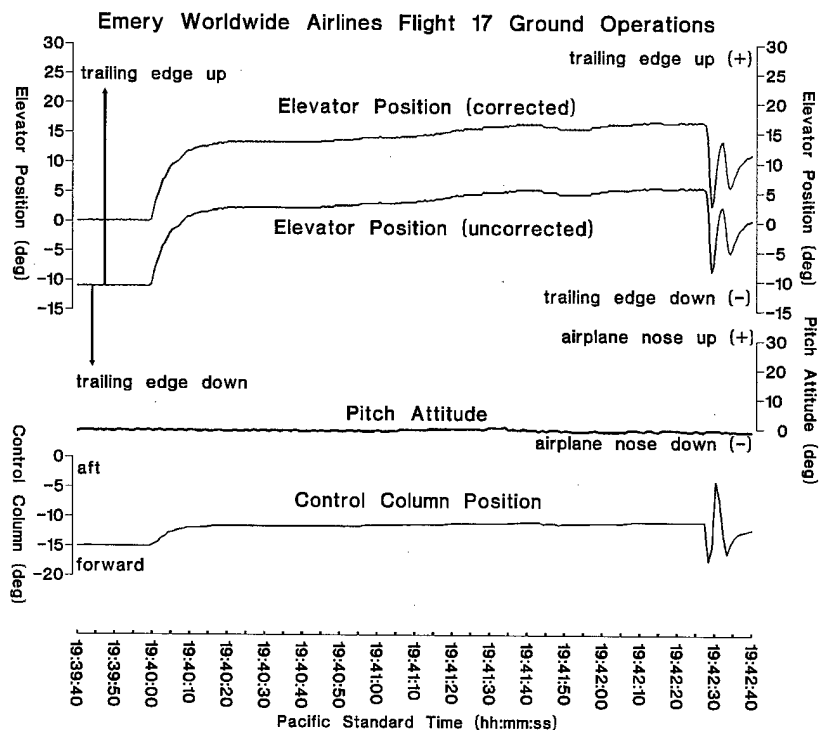
**Figure 6.** Elevator, pitch, and control column plots recorded by the accident airplane's FDR during ground operations before the accident flight. The first 20 seconds of data were recorded while the gust lock was engaged.

The Safety Board's examination of the corrected elevator position data revealed that the airplane's elevator never traveled below its neutral position to a TED deflection during the accident flight, although recorded forward control column inputs should have resulted in a TED elevator deflection. For example, although the FDR data indicated that, during the 80-knot elevator check at MHR, the control columns were moved to about 6° forward of their rigged neutral position, the elevators did not deflect below 2.2° TEU. In contrast, during the 80-knot elevator check on the previous takeoff (at RNO) the FDR recorded elevator movement to 8° TED, with less forward control column movement. Figure 7 shows plots of the pitch attitude, control column position, and elevator position FDR data for the accident flight. Elevator position is shown using the conversion that corrected for the 11° offset. Figure 7 also shows when the 80-knot elevator check and takeoff occurred. Figure 8 shows the same information for the takeoff from RNO.

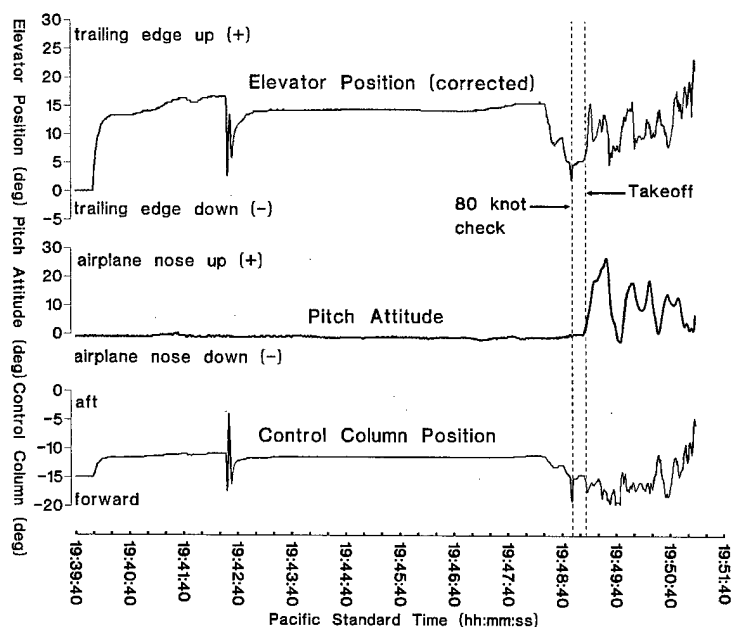
**Figure 7.** Pitch attitude, control column position, and (corrected) elevator position FDR data from the accident flight. About the first 20 seconds of data were recorded while the gust lock was engaged.

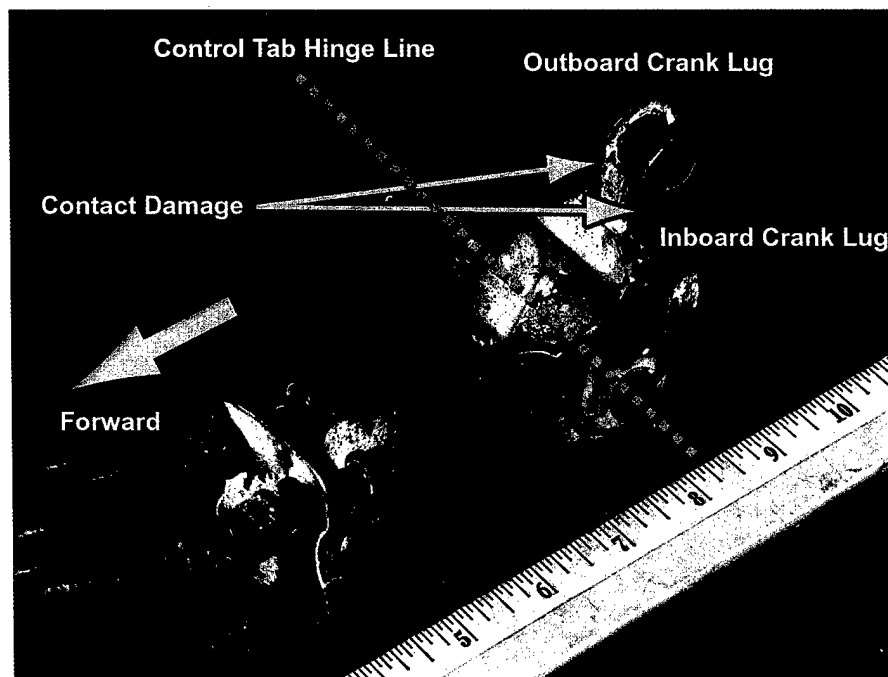
The National Transportation Safety Board determined that the probable cause of the accident was a loss of pitch control resulting from the disconnection of the right elevator control tab. The disconnection was caused by the failure to properly secure and inspect the attachment bolt.

(See figure 2, in section 1.6.2, for a diagram of the elevator control tab installation.) The right control tab pushrod was recovered separately, with its aft rod end (which would normally have been bolted to the tab crank fitting) intact. Examination of the forward edges of the elevator control tab crank fitting lugs revealed evidence of repeated contact damage (including gouge marks and indentations). (Figure 9 is a photograph of damage to this area.) The internal surfaces of the pushrod aft rod end bearing and the bushings in the crank fitting lugs showed no visible signs of damage or deformation. The bolt and associated hardware that normally secures the right elevator control tab pushrod to the tab crank fitting<sup>61</sup> was missing and not recovered.

**Figure 9.** A photograph of the accident airplane's right elevator control tab crank fitting. Note damage on forward face of control tab crank fitting lugs.

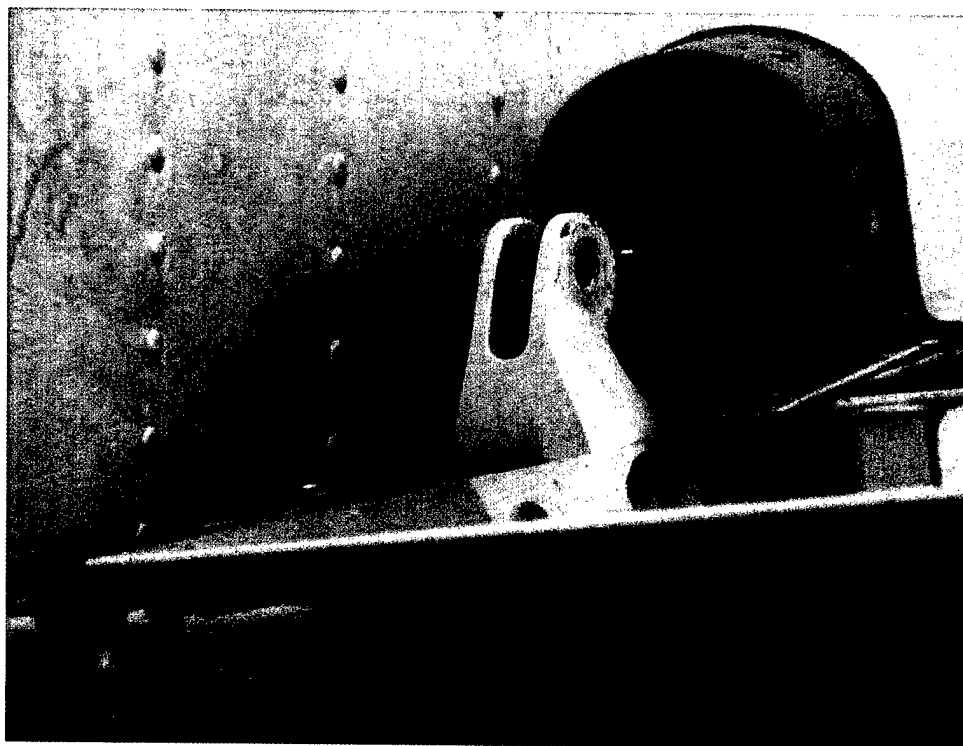
Because a free elevator control tab pushrod might not necessarily always displace itself inboard into alignment with the crank fitting as it did on the test airplane (especially if the pushrod is disconnected while the airplane is in flight and aerodynamic forces are acting on the flight control surfaces), the Safety Board examined other potential interference modes between a free elevator control tab pushrod and crank fitting. These tests revealed that in general, contact between a free pushrod and the forward face of either crank fitting lug (accounting for rod end misalignment, etc.) resulted in a mismatch of approximately 25° between the left and right control tabs. These tests also revealed that a disconnected control tab could be rotated about 3° to 4° in the TEU direction if the crank fitting remained centered about the pushrod; however, further movement was restricted by contact between the crank fitting and shoulders of the aft end of the pushrod. Figure 11 is a photograph of the test airplane's control tab in this position.

**Figure 11.** Photograph of the test airplane's disconnected right elevator control tab pushrod centered between the lugs of the crank fitting with the control tab rotated 3° to 4° in the TEU direction after the attachment bolt was removed.

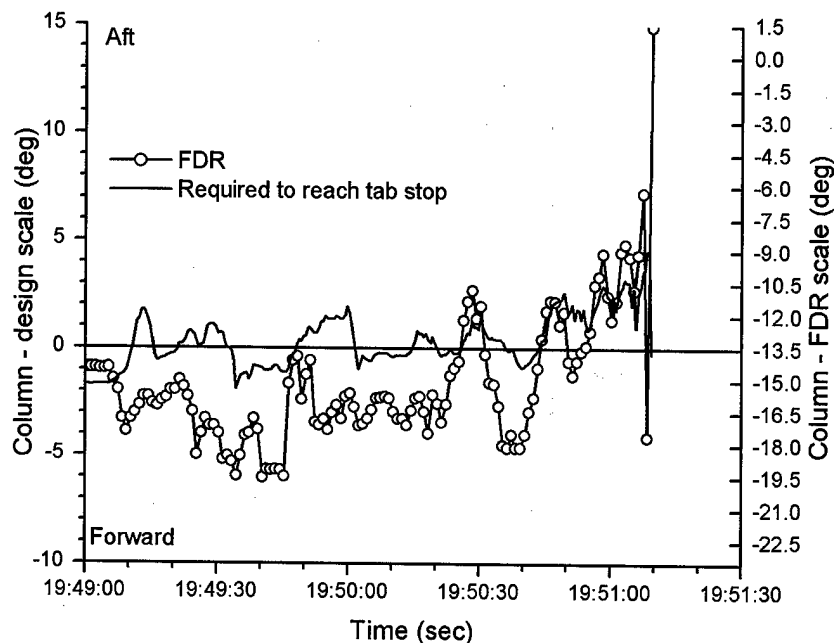
The Safety Board's examination of the FDR data for the flights preceding the accident flight revealed that a change in the relationship of control column movement to elevator response occurred about 8 minutes and 20 seconds before the accident airplane landed at MHR. The Board's performance study derived the control tab positions at the time of this change. The study showed that the change in FDR data could be explained by a shift of about 3° to 4° in the TEU direction of the right control tab, assuming that the right control tab's pushrod to crank fitting attachment bolt separated at this time. This change in the FDR data was evident until the airplane landed at MHR. As previously discussed, a scenario in which a disconnected pushrod remained between the lugs of the aft crank fitting (shown in figure 11) resulted in a 3° to 4° control tab shift in the TEU direction.

**Figure 12.** The control column position required for the left elevator control tab to reach its TEU physical stop (for the recorded elevator position) and the actual recorded control column position for the accident flight.

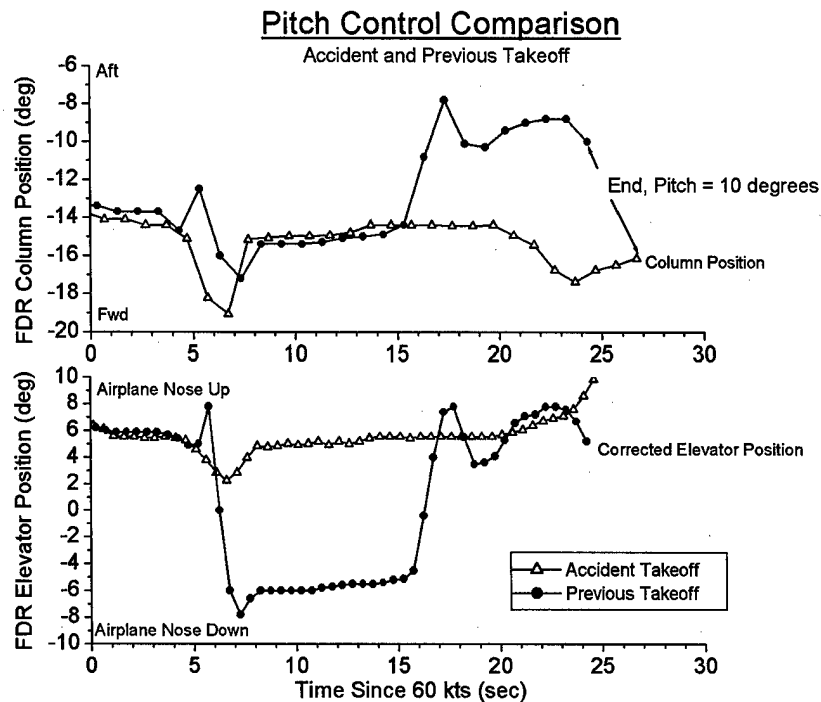
The study also showed that the stabilizer moved in an ANU direction at the same time that the pilot pushed the control column forward to resume the descent after a brief period of level flight at 10,000 feet. The direction of this stabilizer movement was opposite that which would be expected when the pilot provided a forward control column input. The study showed that the slight ANU stabilizer shift balanced the effect of the change in the relationship between the recorded elevator and control column movements and that the elevator remained responsive to pilot input. Figure 13 shows plots of the control column and elevator for the accident takeoff roll and the previous takeoff roll (from RNO).

**Figure 13.** Plots of the control column and corrected elevator position recorded by the accident FDR during the accident takeoff roll and the previous takeoff roll (from RNO).
